State of Utah
DEPARTMENT OF NATURAL RESOURCES
Division of Oil, Gas & Mining

Inspection Report

Mine Name: Rhea Rae
Operator Name: Black Gold Organic Fertilizer

Permit number: S0190064
Inspection Date: November 19,
2007
Time: 4:20-5:00 PM

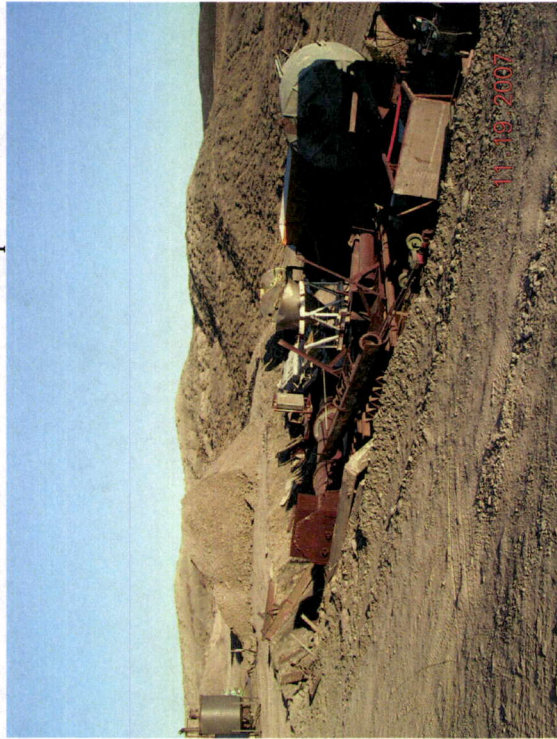
There are various piles of earthen material at the site. Some is in embankments for the two ponds, and one pile, shown on the left side of Photo 1, I thought might be topsoil. Mr. Andrus told me, however, that this pile was material they were planning to process and that no soil was saved.

I had intended to issue the operator a notice of violation for not salvaging soil, but the operator explained that the upper layers of material were used to build the embankment for the lower pond. This material is still available for use in reclamation and, since the pond has not been used, it has not been contaminated.

Photo 1. In the left center of this photo is a pile of material that was to be processed. I found no other material in what might have been a soil stockpile.

The operator is considering various options for processing the mined material and may not use the pond at all. If the pond is to be used, the operator needs to find a way to protect the soil or to replace it with soil from another location. Before using the pond for processing operations, the operator will need to submit an amendment to the Notice of Intention showing either how the embankment material will be protected or how this will be replaced. At that point, the Division will need to examine whether the existing reclamation surety is adequate, especially if soil is borrowed from another area.

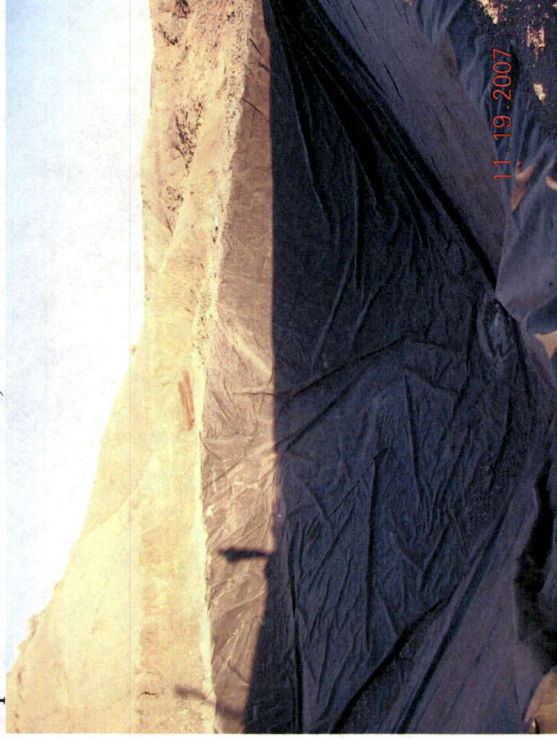
Photo 3. The upper, lined, pond.

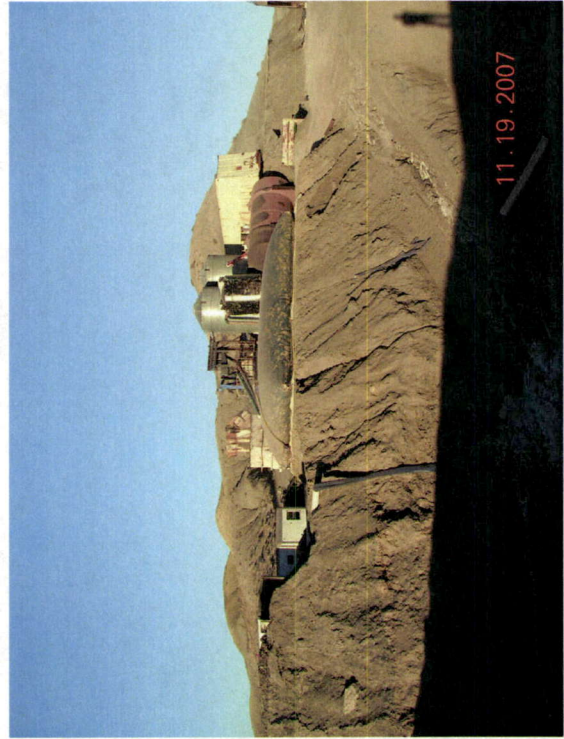
Photo 2. The lower pond and one of the water bladders.

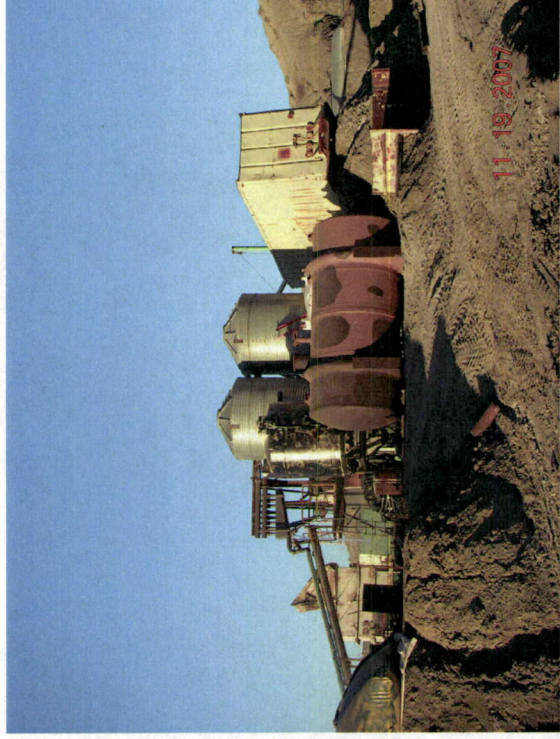
Photo 4. This is the processing area.

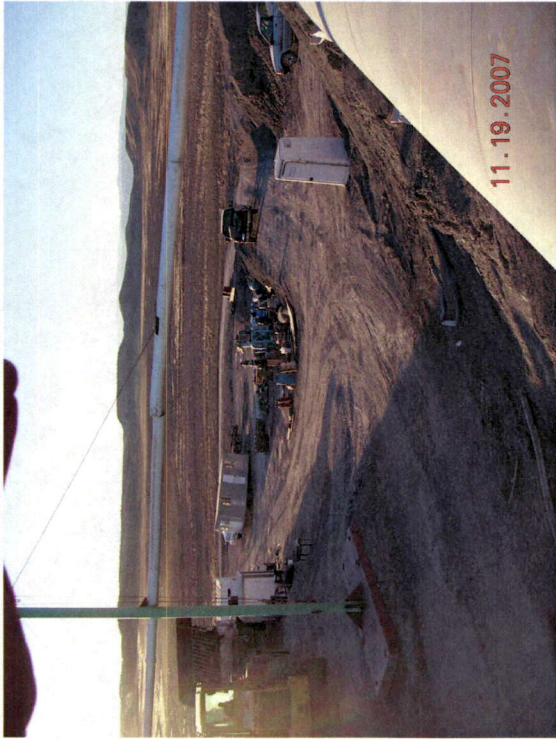
Photo 5. An overview of part of the mine site.

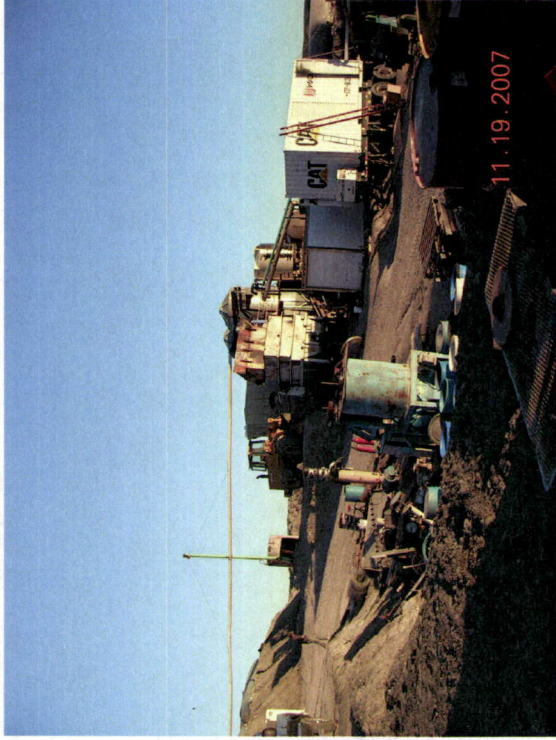
Photo 7. Another view of the processing area.

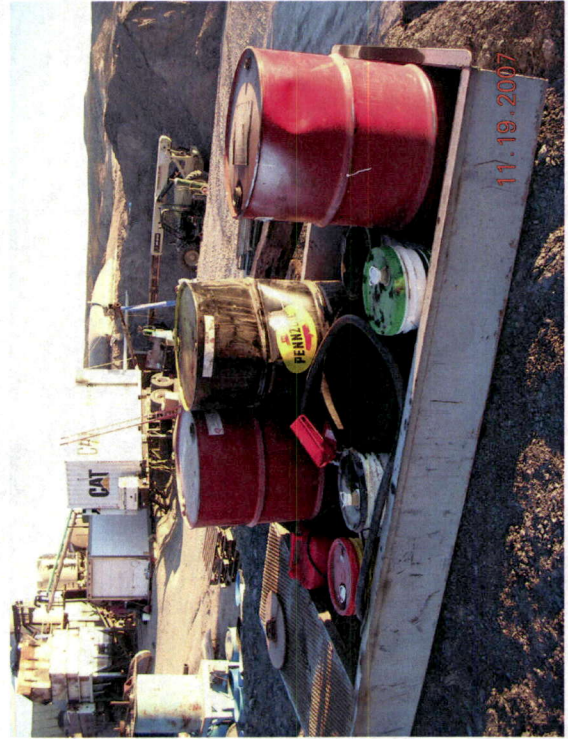
The container for the oil products appeared to be marginal for the number of drums and buckets that were in it. The operator should consider getting another container.

Photo 6. An oil containment area.

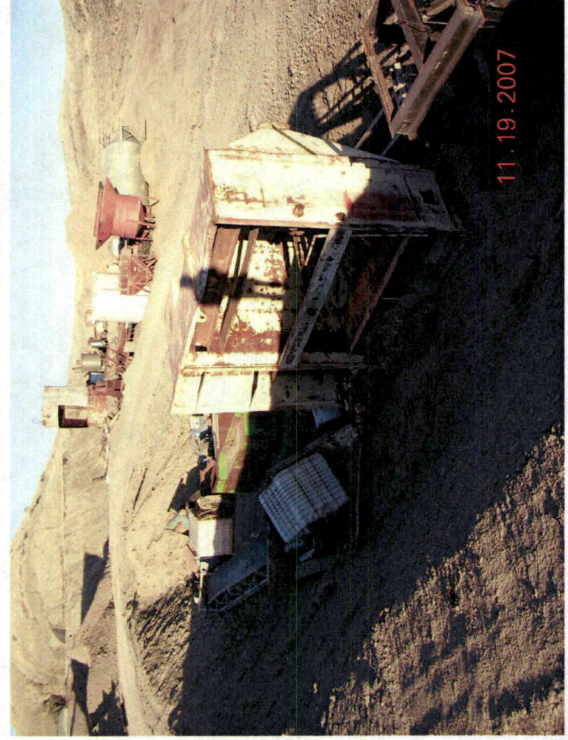
Photo 8. Some of the equipment that is not yet being used.
